Red Dog Restaurant  
 66 Bold Street  
 Liverpool  
 L1

UK Services  
 18 – 20 Menta Business Park  
 Holland's Road  
 Suffolk, CB9 8PU

**Start Date – 7<sup>th</sup> November**

**Work Completed – 9<sup>th</sup> November**

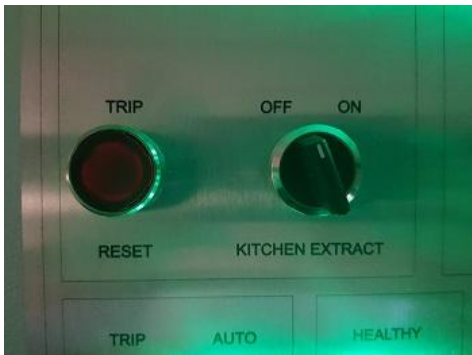
The control panel for the extraction system is in the office; Zsolt (GM) was very accommodating and allowed us to have his keys so that we may isolate the fan when cleaning.

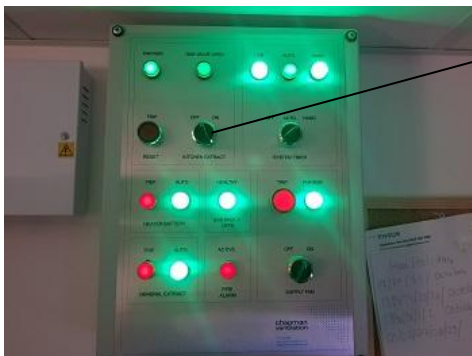
Fan switch, once off placed a sign over control panel so nobody would switch fan back while working.

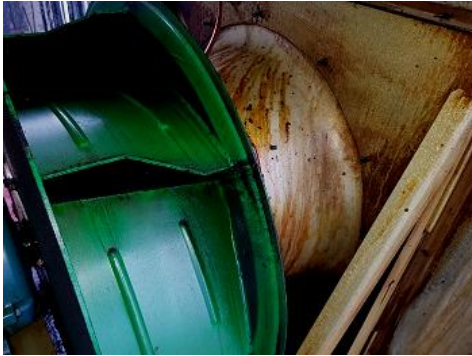
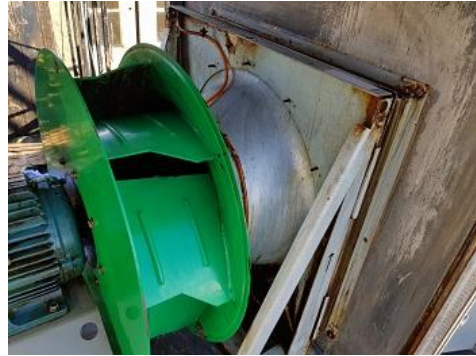
**Pre Clean**

**Post Clean**

We left Suffolk at 3am and arrived at the Restaurant 8.30am, the Chefs kindly held off cooking until 10.30am so that we may clean fan, the Chefs and Management were very accommodating. We started by opening the 2 large access panels either side of the fan, we noticed there was high levels of liquid grease contamination on the floor of the fan housing, we were unable to take micron levels because it had not yet solidified however we were able to take micron levels from the side of the fan housing. Micron levels were low to medium, micron readings levels were as follow; Door – 330 microns, Side walls 330 to 550. These levels indicate an immediate clean, the levels were a little higher than the last clean, however the adjoining ductwork have low micron readings which is a good sign. We started by scraping grease from walls, ceiling and floor of housing, once complete we sprayed the housing with a sodium hydroxide solution, once the chemical had broken down contamination we used scourers, hand held pressure washer in conjunction with Ubik 2000 degreaser to remove all contamination, results were very good and micron readings were "0" after clean.

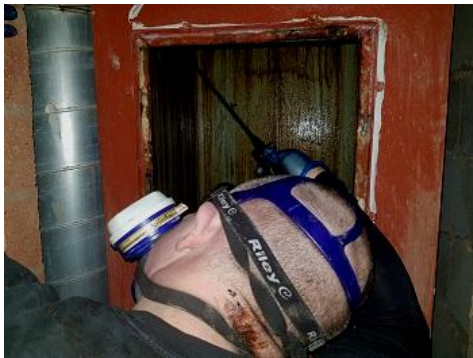
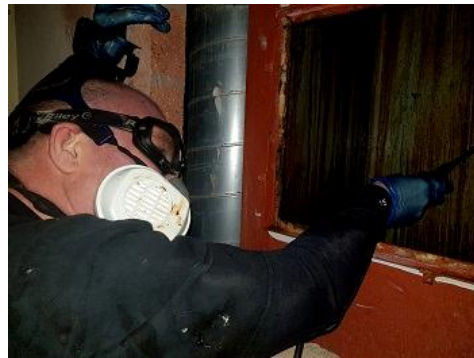
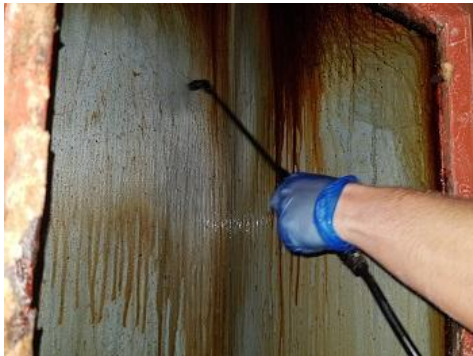
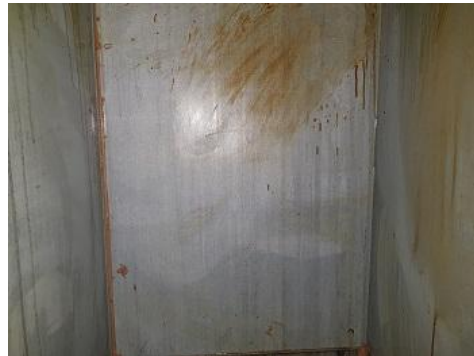
There are 4 internal access panels and 2 on the roof in which to clean internal riser, you can see how the chemical breaks the grease and runs down the riser, the process is repeated as many as required to achieve TR19 standards.

**Chemical breaking down the grease contamination.**

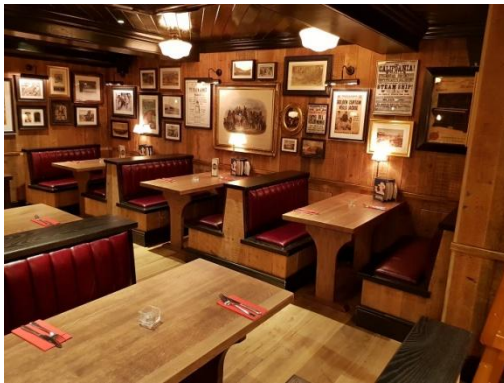
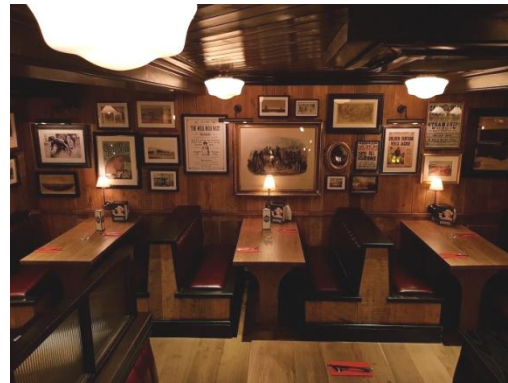
**Furniture**

There is approximately 10m of header above canopy and another 5m of adjoining ductwork that continues to the Riser. Before you can access the header you must first remove all the furniture which is fitted within the top floor of restaurant. As you will see by the photographic evidence, there are 4 access panel in which to clean Header, one access panel on left side so that you can climb in to access bottom of Riser and top of Header, then another door to the right side of far wall in which to clean Header above the smokers. A total of 6 access points are available, **access is very good for the whole of the restaurant.** We coated all areas of ductwork with sodium hydroxide solution then used an Ubik 2000 degreaser in conjunction with a pressure washer to clean all areas of ductwork to TR19 standards. It is a little difficult to access the small risers from canopy to header.

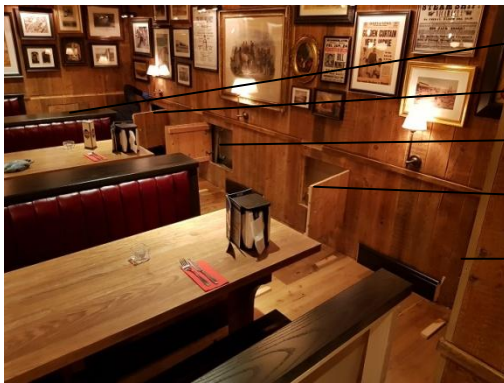
**Access Points to Header**

- Access to Bottom of Riser and Top Header
- Access Panel 1 to Header
- Access Panel 2 to Header
- Access Panel 3 to Header
- Access Panel 4 to Header
- Access Panel 5 to Header above Riser is behind door.

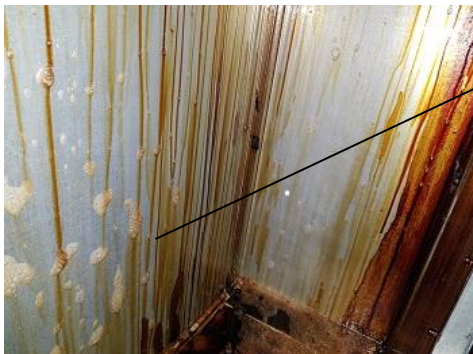
Once sprayed or coated with sodium hydroxide the grease and carbon contamination starts to break down, we then use scourers, micro fibre cloths in conjunction with Ubik 2000 degreaser to remove all contamination.

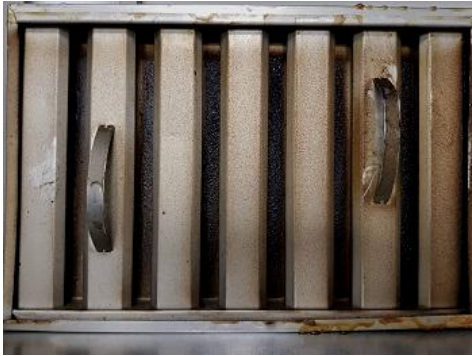
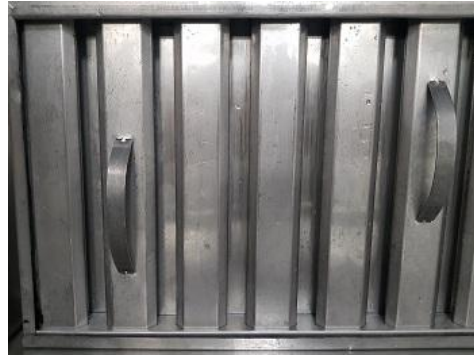
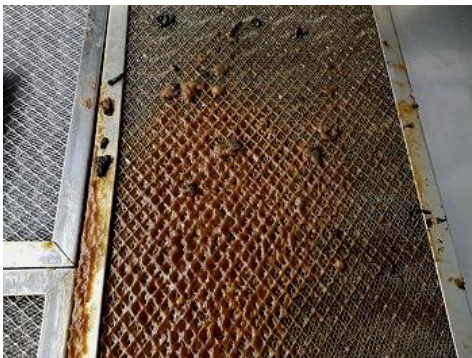
The fryer and hotplate side of the canopy had medium to high levels of contamination; however the grills and Ansell system had very high levels of both carbon and grease contamination. We first scraped a majority of the contamination from the grills and Ansell system before using a paint brush to apply a concentrated sodium hydroxide. Once chemical had broken down grease and carbon we used small wire brushes to remove

contamination, once complete we spray the canopy with Ubik 2000 degreaser then removed all the contamination. **Results were very good and "0" microns were recorded after clean.**
